## CLUTCH DISC FACING CONTAMINATION **TIPS + TRICKS**

ALL Valeo Clutch Kits

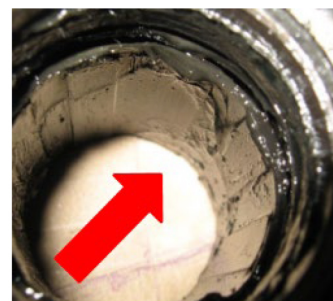
### COMMON CAUSES FOR CONTAMINATION OF CLUTCH DISC FACING

#### 1. Using too much grease during installation of the clutch disc or release bearing

#### 2. Leaking rear main seal (crank shaft seal)

- Use only the included Valeo grease pack for lubricating the disc splines and release bearing.
- Apply a thin film of grease to splines and inner bearing sleeve. Wipe off any excess.
- To avoid potential contamination, wipe off all surfaces outside of the splines and inner bearing sleeve that can spread from rotational force during operation.

- Before installing a new clutch kit, inspect and/or replace the engine rear main seal if leaks or damages are detected.
- It is recommended to replace the rear main seal when performing a clutch kit installation to avoid having to prematurely perform the repair procedure again.
