TIPS AND TRICKS

CLUTCH DISC FACING CONTAMINATION

All applications

All Valeo clutch kits

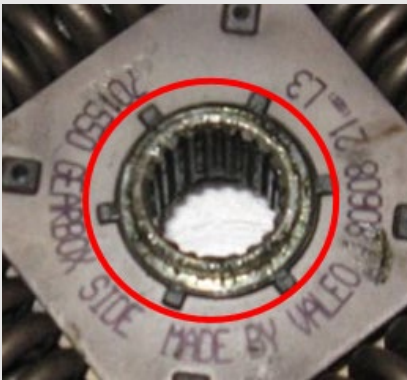
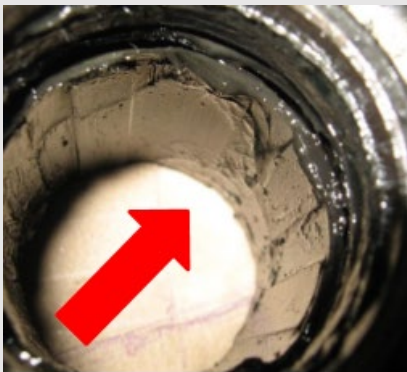
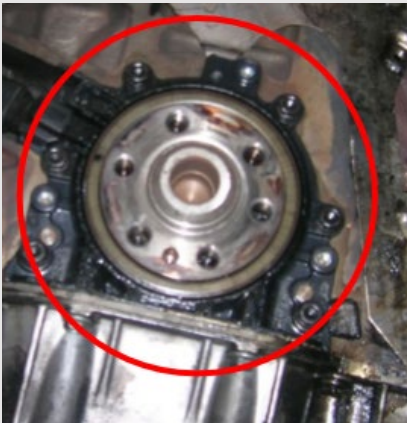
COMMON CAUSES FOR CONTAMINATION OF CLUTCH DISC FACING

1. Using too much grease during installation of the clutch disc or release bearing

2. Leaking rear main seal (crank shaft seal)

- Use only the included Valeo grease pack for lubricating the disc splines and release bearing.
- Apply a thin film of grease to splines and inner bearing sleeve. Wipe off any excess.
- To avoid potential contamination, wipe off all surfaces outside of the splines and inner bearing sleeve that can spread from rotational force during operation.

- Before installing a new clutch kit, inspect and/or replace the engine rear main seal if leaks or damages are detected.
- It is recommended to replace the rear main seal when performing a clutch kit installation to avoid having to prematurely perform the repair procedure again.
