TIPS AND TRICKS:

Why Checks Should Be Made Before Fitting

All applications **Part numbers** All Valeo A/C COMPRESSORS

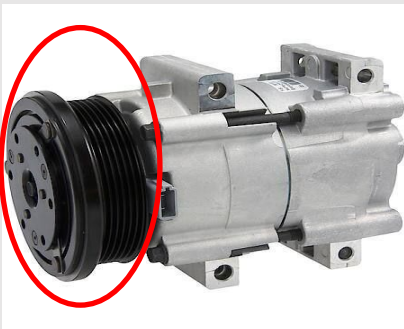
Check the pulley size the off set and belt type to the original compressor

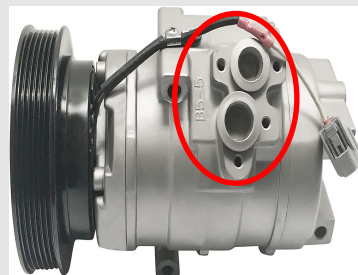
Compare the mounting points and fixing brackets match the original compressor
